# NATIONAL BUREAU OF STANDARDS REPORT

AN INTERIM REPORT ON BOILING TESTS  
OF  
INSULATIONS FOR UNDERGROUND HEAT DISTRIBUTION SYSTEMS

1003-20-4881

October 28, 1958

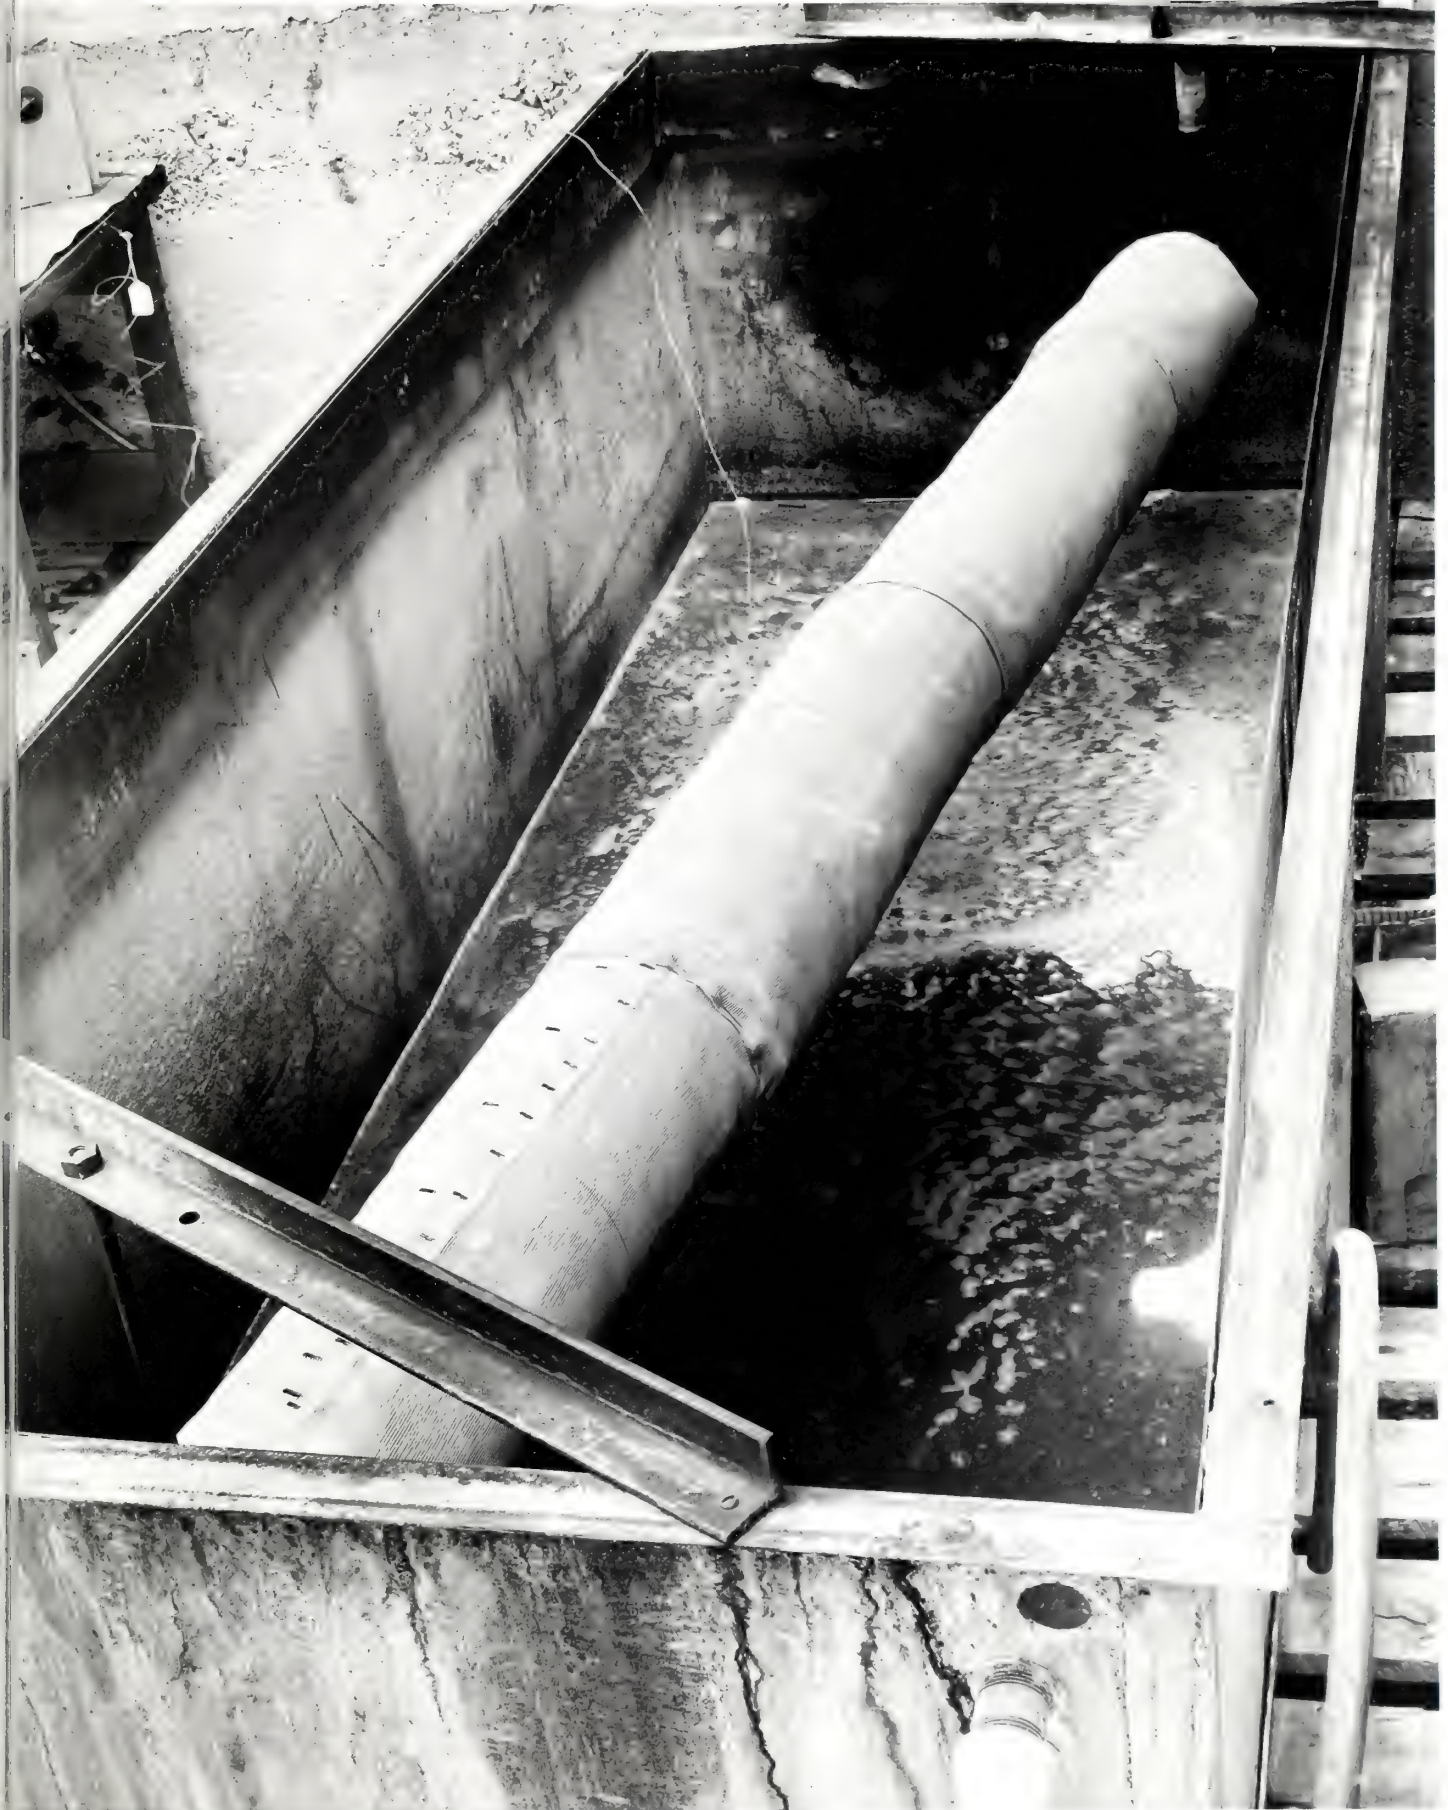
Figure 5

Reference to photographs: Fig 5 - after 72 hrs boiling  
Fig 6 - buttjoint uncovered to show negligible loss of wool  
Fig 7 - after 144 hrs boiling shows some loss of Fiberglas wool

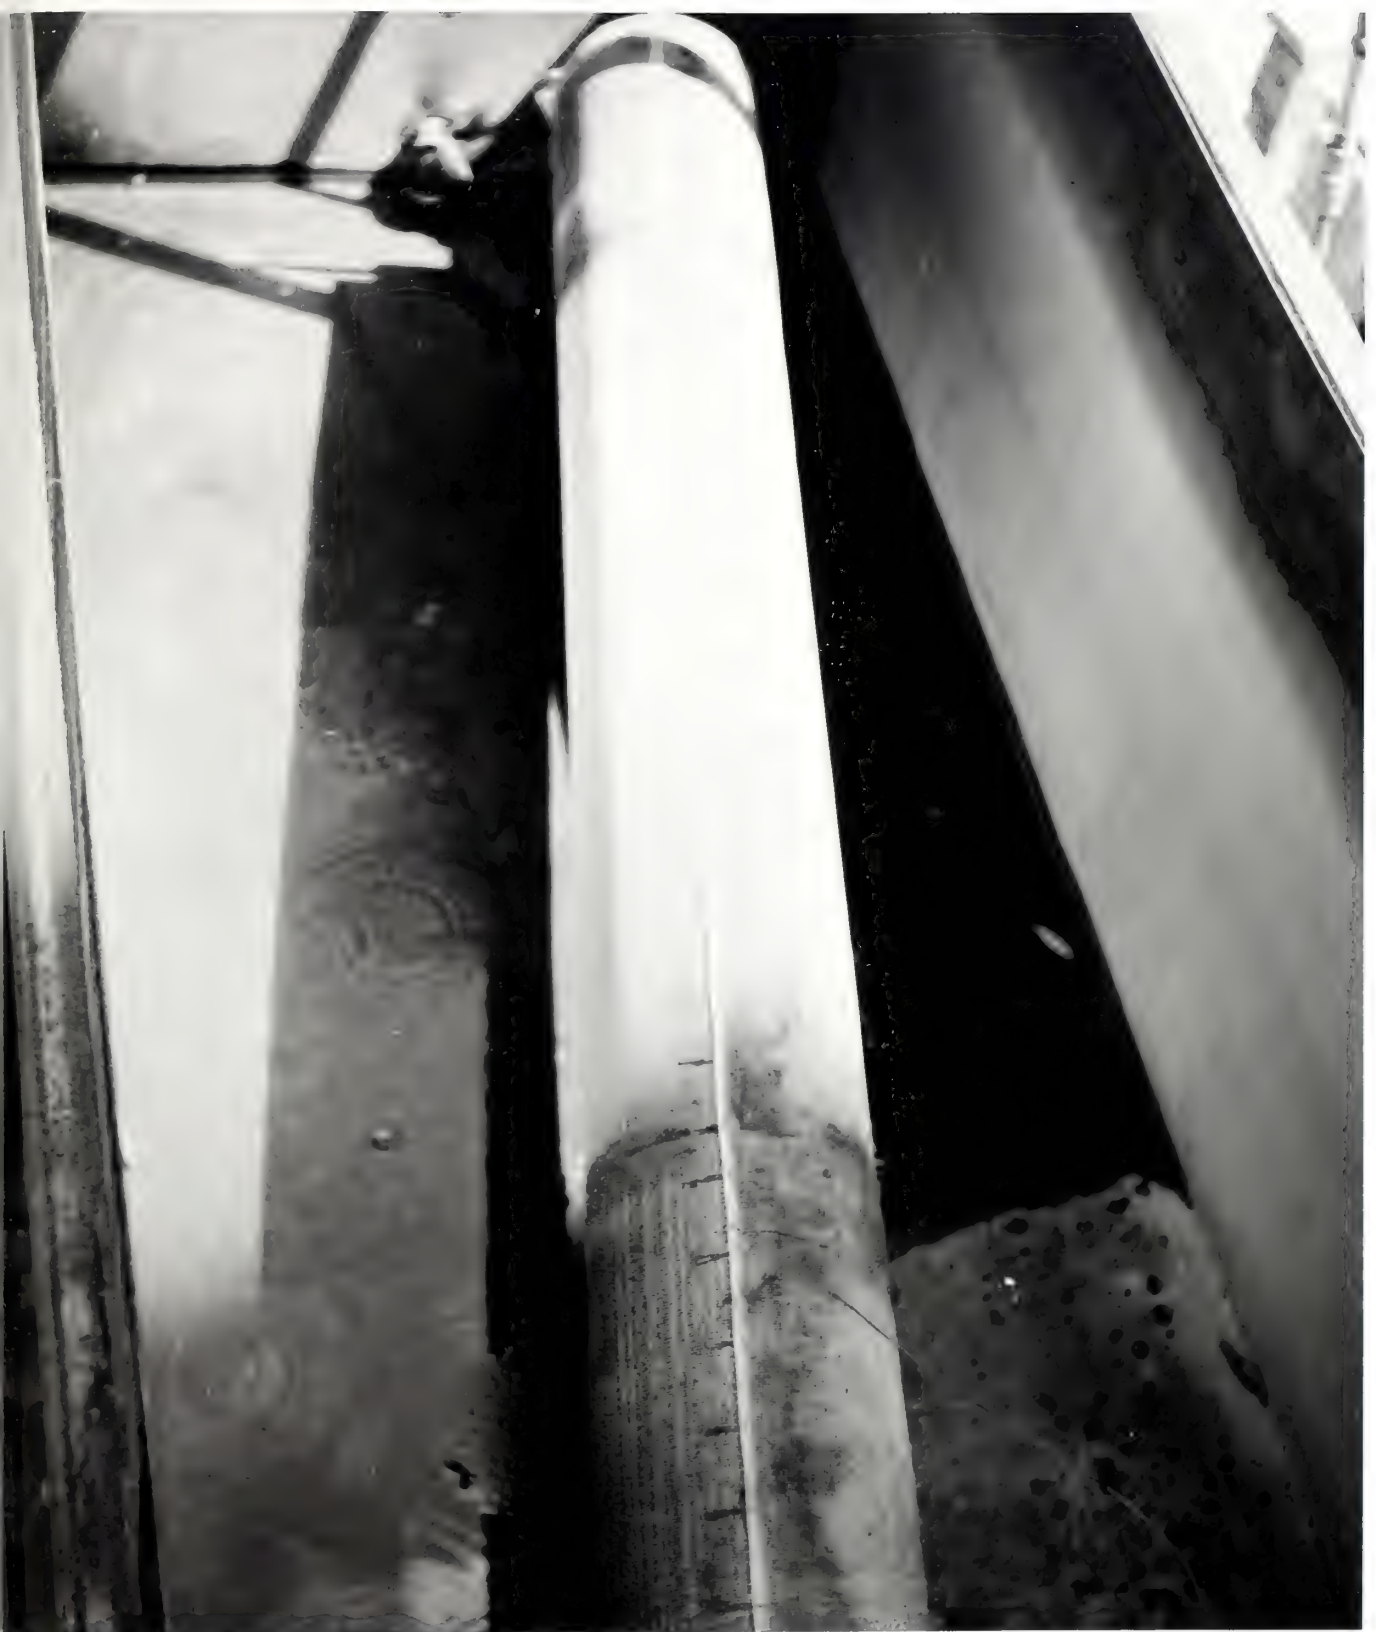
Figure 10

Other damage: No damage that could be observed after 72 hrs. Except for the slight erosion at the joints and the usual embrittlement of the glass fibers, this specimen was in good condition after 120 hrs of boiling.

Reference to photographs: Fig 10 is a view of the specimen after 120 hrs of boiling.

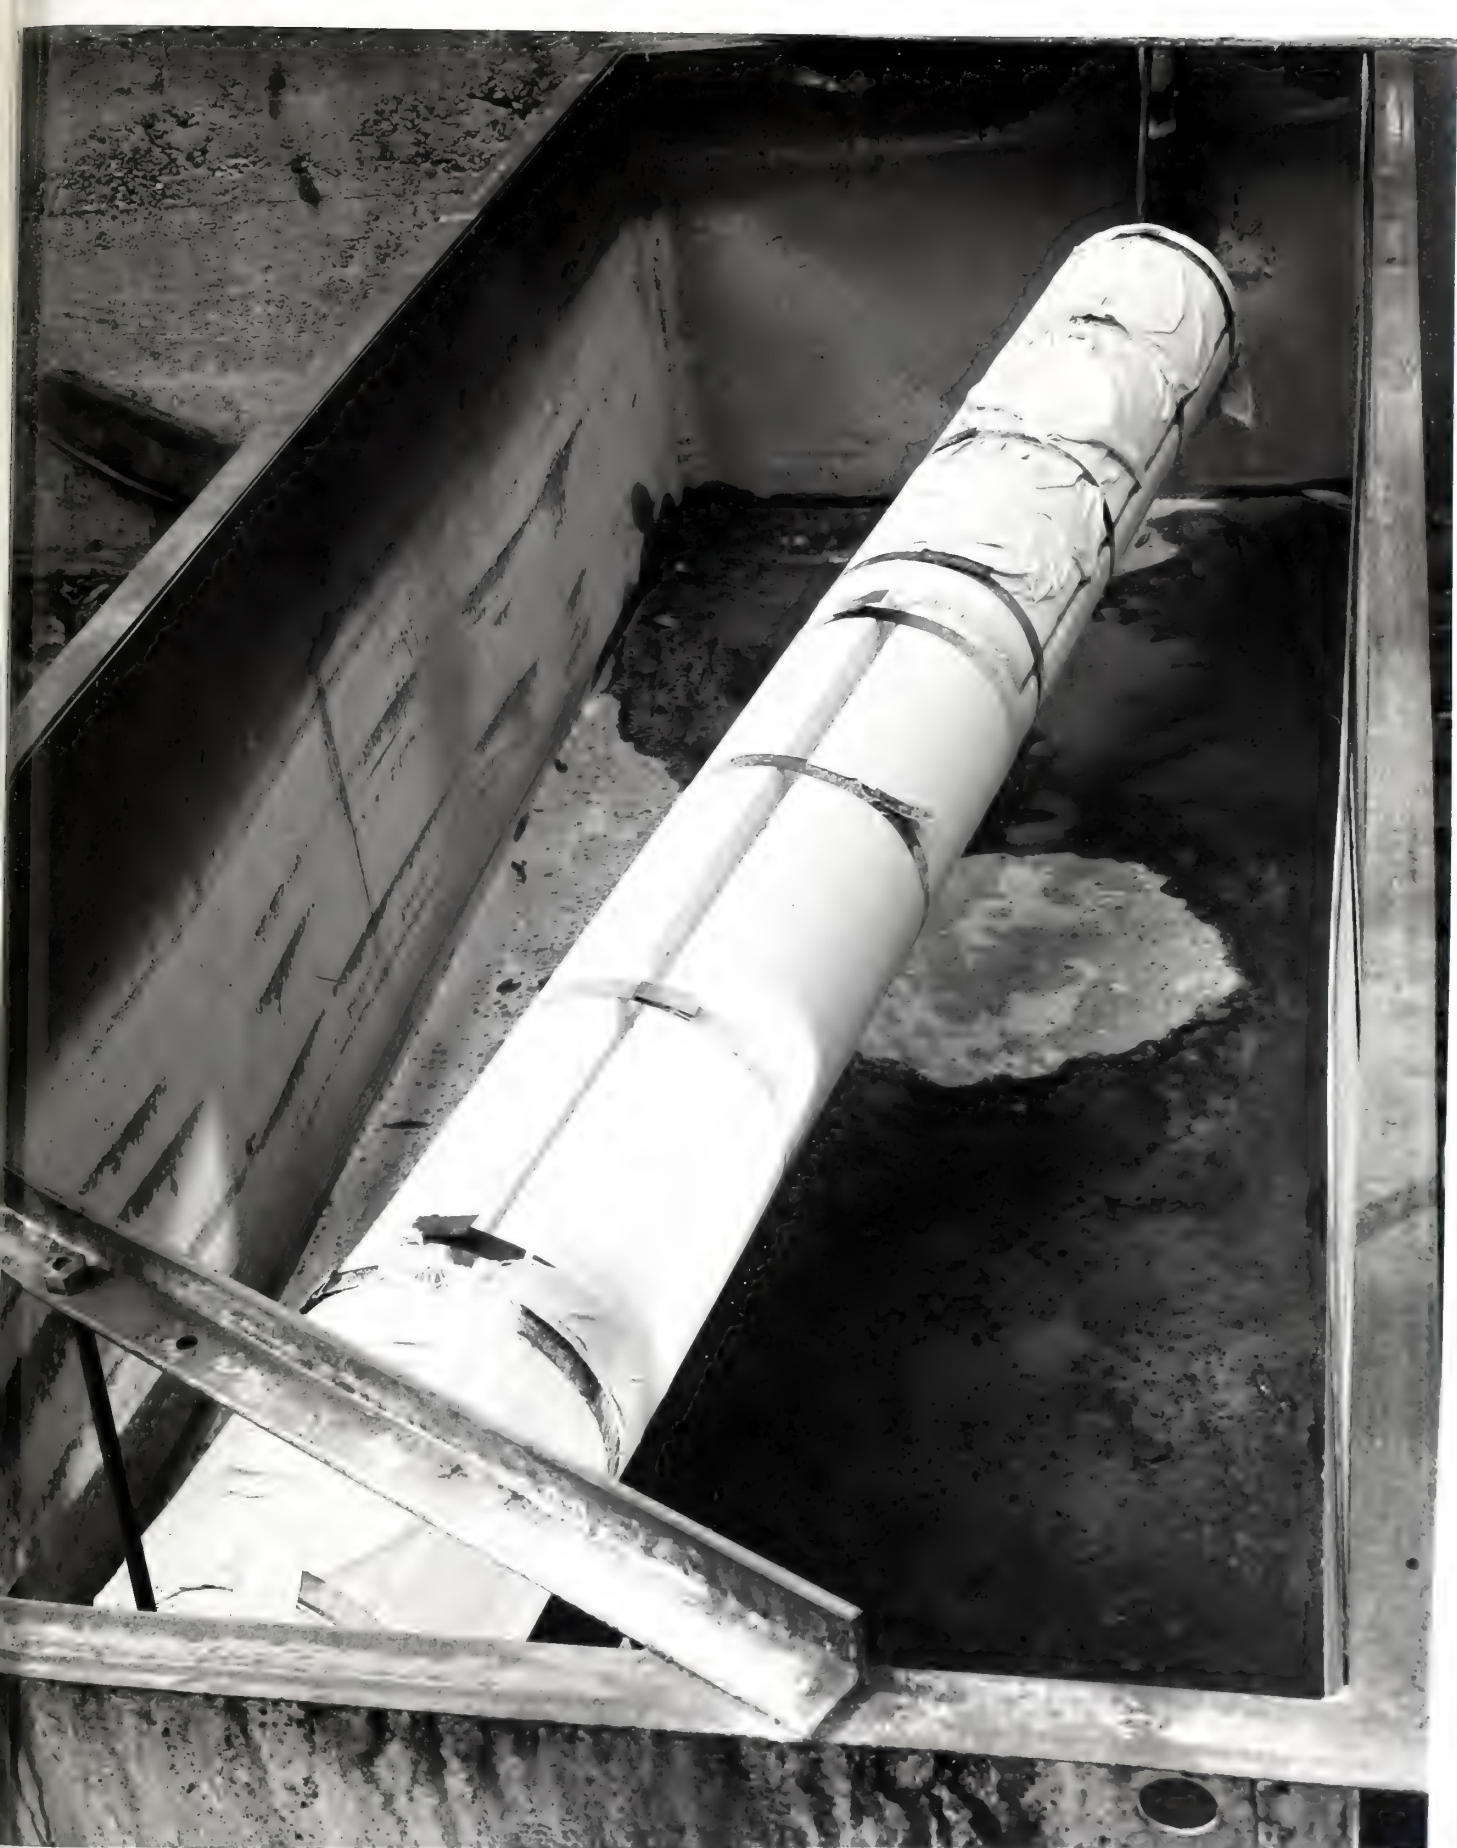
figure 17

Reference to photographs: Fig 17 shows appearance after 72 hours boiling

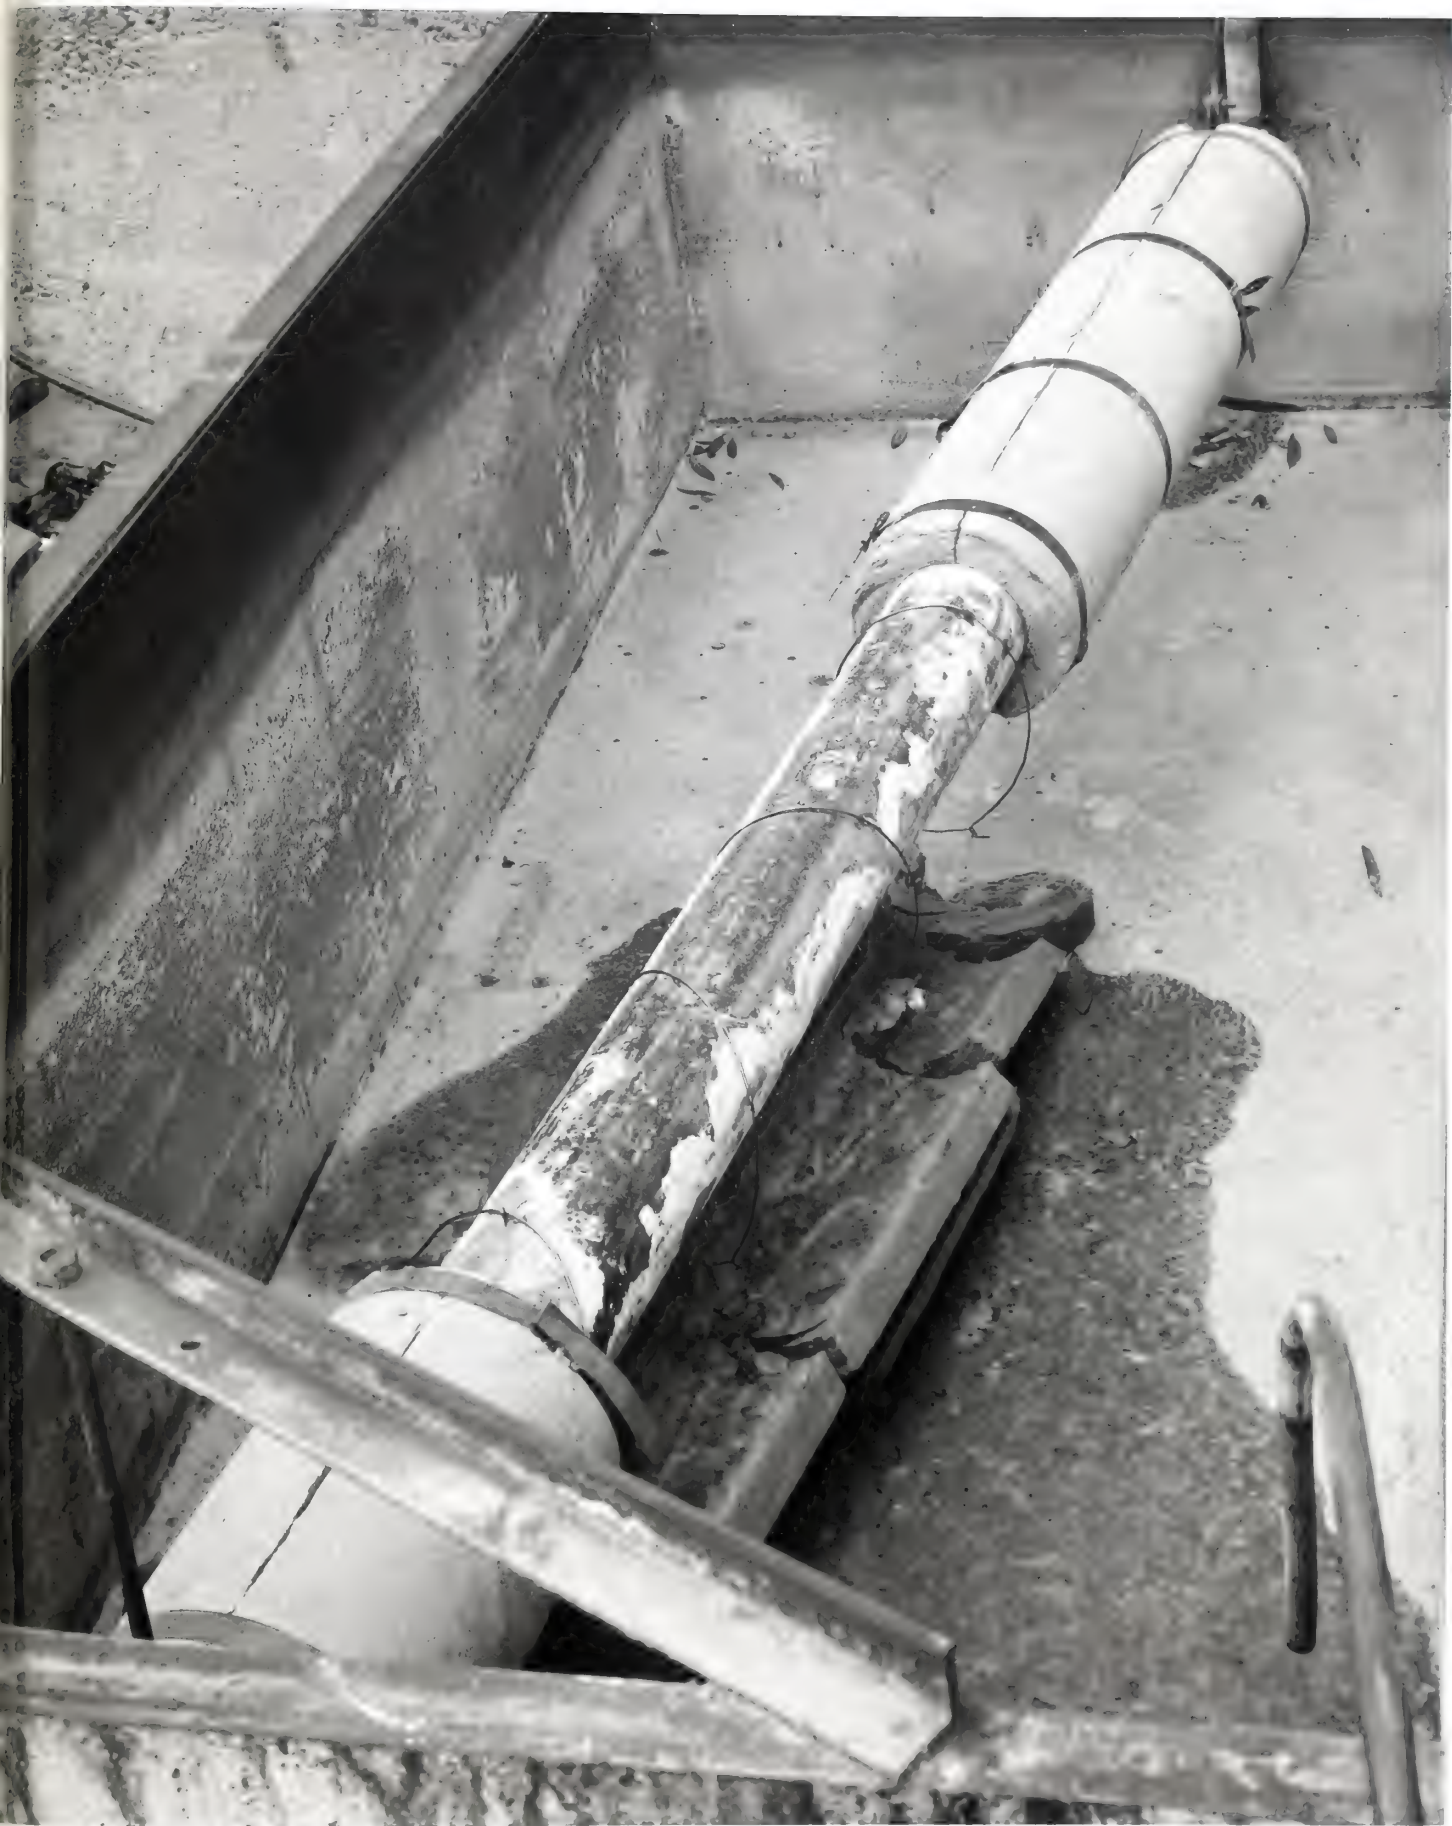
Figure 18

Reference to photographs: Fig 18 shows the appearance of the ins-  
ulation after 72 hours boiling. The  
first section, secured with straps, shows  
slight erosion and fraying. The second  
section, secured with wires, had separated  
from the pipe and a part had fallen into  
the bottom of the tank.
